3R Building Sustainability Office Case Study LEED® Gold Certification for ID+C

LEED Certification: A Company Philosophy

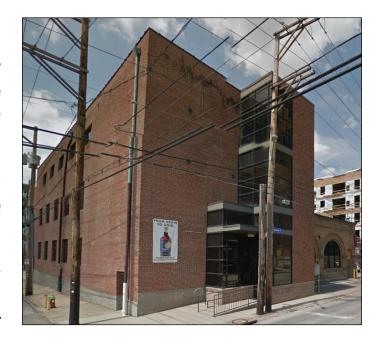
As you enter the office through the main entrance corridor, the restrooms and the kitchen are to the left. Directly in front of you is the conference room and informal seating area. Beyond that is the collaboration room and open work space with pods of two or four work stations. The back of the office houses the server room and storage for office supplies and employee belongings.

Sharing the 3-story building with other occupants, the 3R office occupies the entire 3rd floor of the building. The space is approximately 2,300 SF. It has entrances at the front and back of the building. The southwest wall of the office has 5 large windows that face the city of Pittsburgh and the northeast wall is original brick.

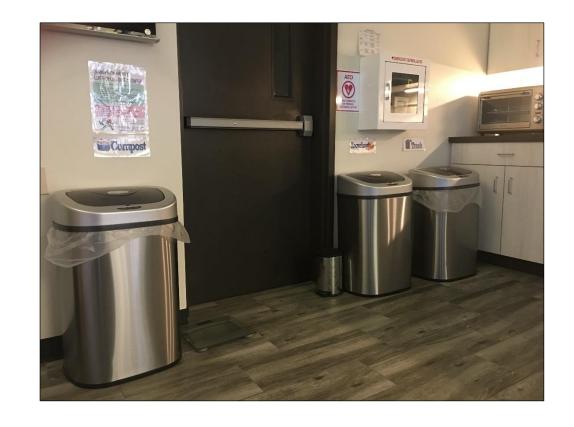
Over 95% of the construction waste was recycled. An effort was made to salvage and recycle as much of the previous build out as possible. Existing doors, light fixtures, and HVAC equipment were reused. (Pictured on next page)

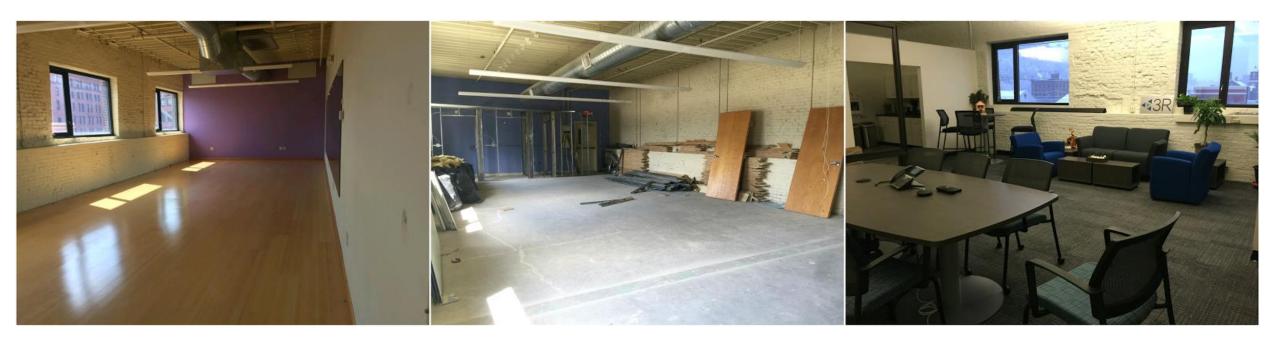
Over 95% of the construction waste was recycled.
